Navajo Abandoned Uranium Mine

Site Screen Report

Grub No. 14 AUM Site

Navajo AUM Western Region

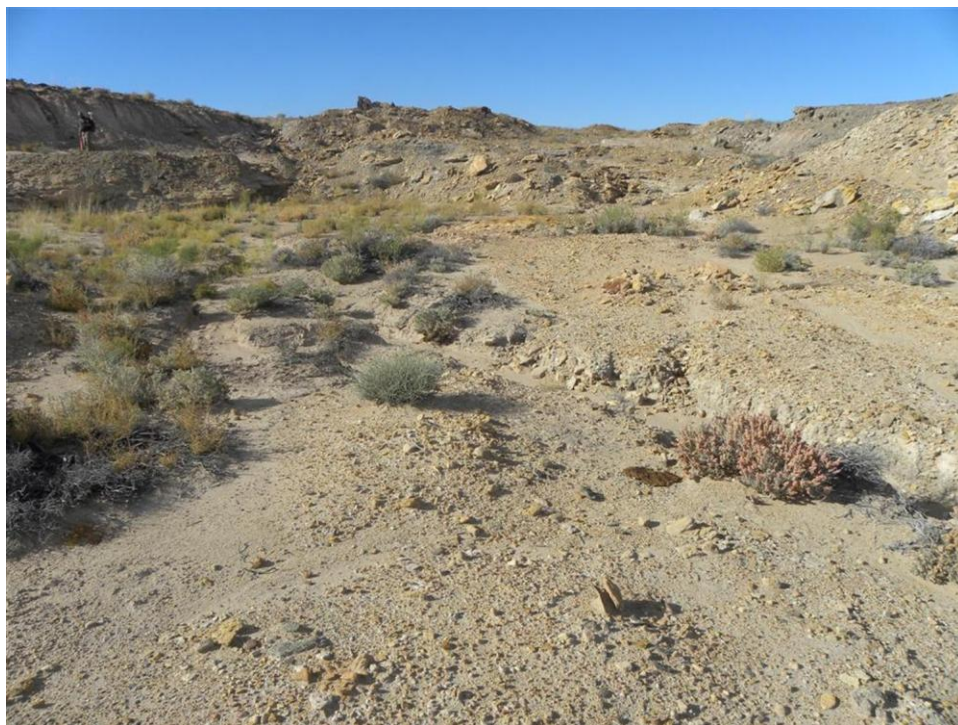
Photo 1. Grub No. 14 mine site

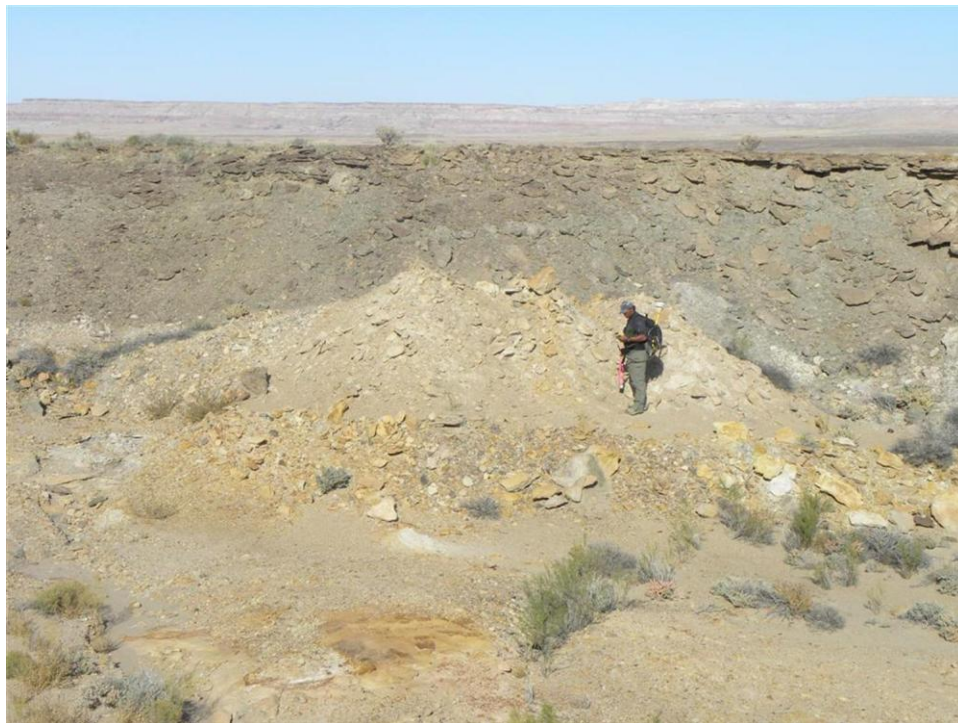
Waste debris pile 30' x 10' x 10', yellow-brown soil in northern portion of site

Photo 2. Grub No. 14 mine site, waste pile

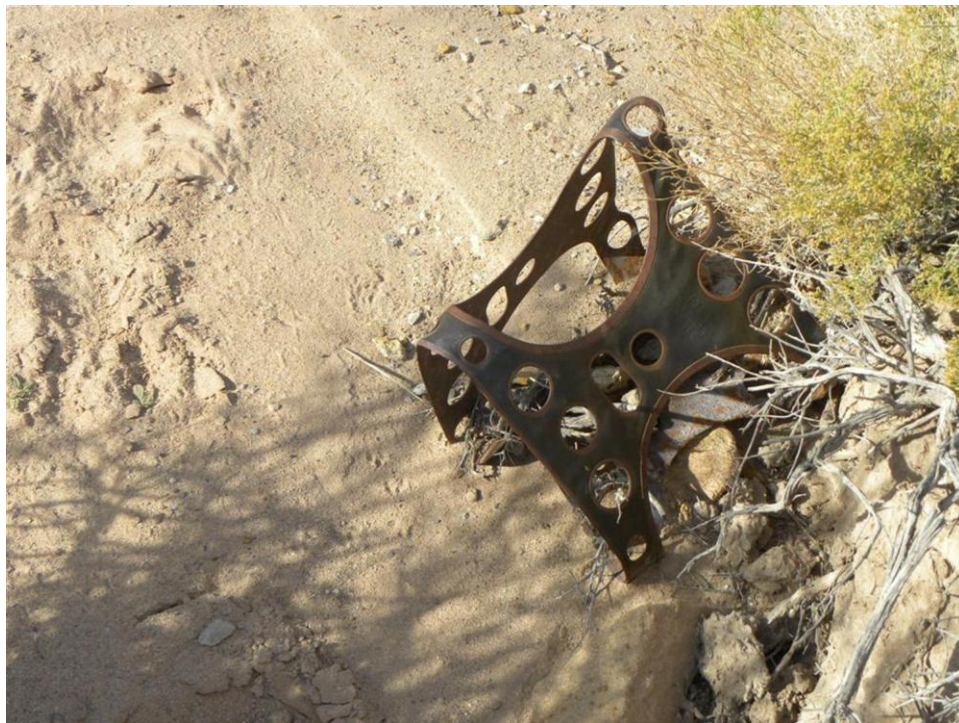
Mining debris in drainage, wooden markers

Photo 7. Grub No. 14 mine site, debris
